BABSON RESERVOIR DAM  
MA 00187

PHASE I INSPECTION REPORT  
NATIONAL DAM INSPECTION PROGRAM

DEPARTMENT OF THE ARMY  
NEW ENGLAND DIVISION, CORPS OF ENGINEERS  
WALTHAM, MASS. 02154

NOVEMBER 1978

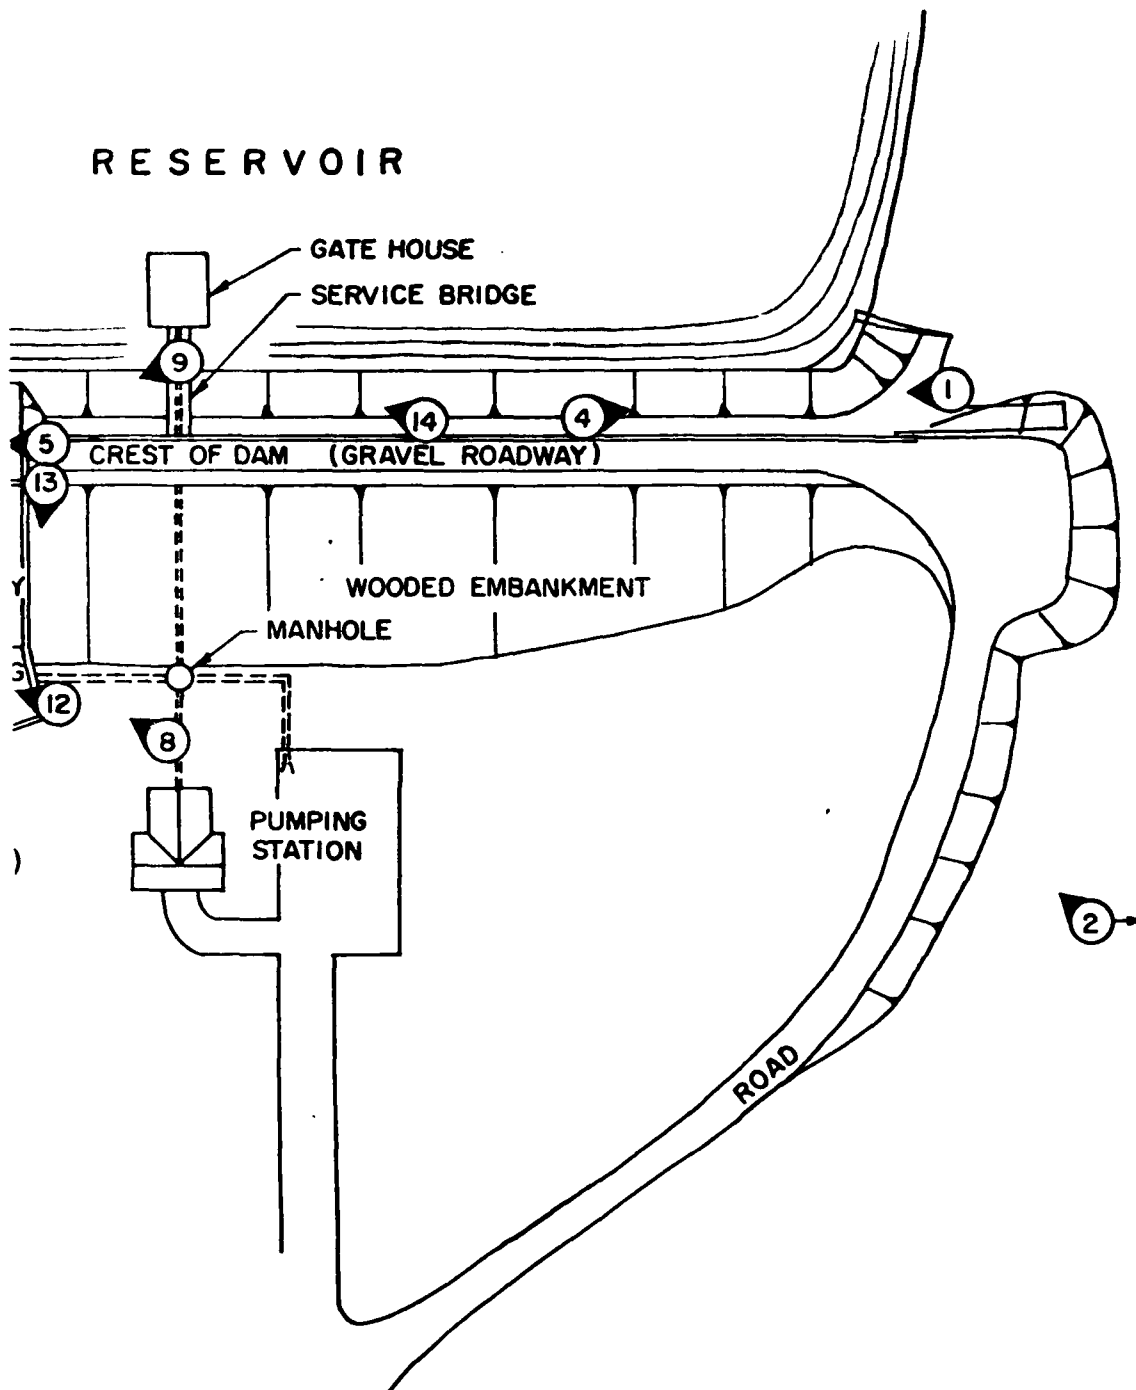
C-1

9.	Spillway approach and log boom	C16	16	6
10.	Downstream face of spillway	8	21	6
11.	Training wall left of stilling basin showing 24-in. blow-off pipe and underdrain outlet	C17	6	7

12.	Training wall right of stilling basin	8	4	7
13.	Discharge channel downstream of spillway	8	6	8
14.	Gate house and service bridge	8	8	8
